## Rocky Mountain Village Estates *Evergreen, CO*

Report #: 8361-8  
Beginning: January 1, 2027  
Expires: December 31, 2027

# RESERVE STUDY Update "With-Site-Visit"

August 6, 2026

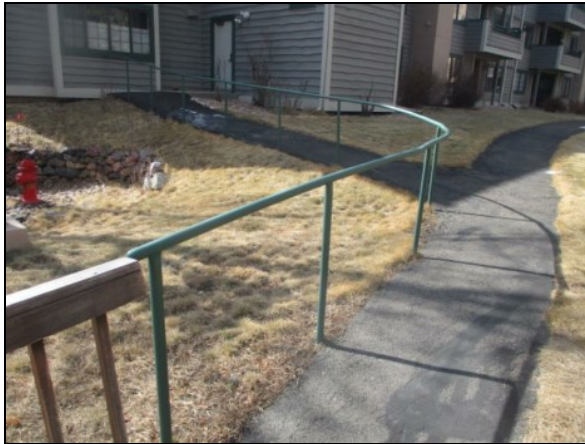
**Comp #: 21300 Site Rail: Metal - Repair/Paint****Approx Quantity: 160 LF****Location:** Common Areas**Funded?:** No. Reportedly painted as an Operating expense.**History:****Comments:** Client reportedly paints the handrails as an on-going Operating expense. No recommendation for Reserve funding at this time.**Useful Life:****Remaining Life:**

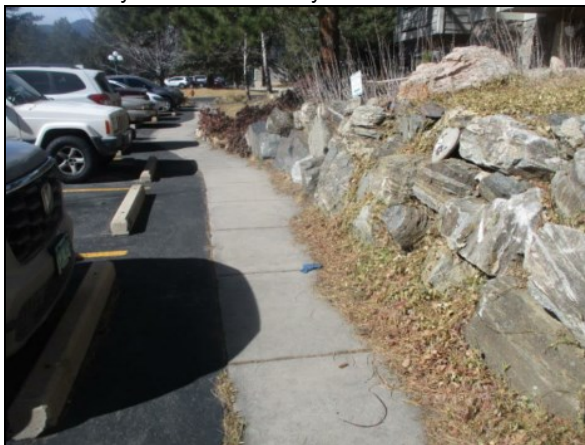
**Comments:** No significant or widespread settling or other problems observed. Assumed to have been properly designed and installed with adequate base and surrounding drainage. Inspect regularly, repair as needed from Operating budget. If shifting, cracking, etc. are observed, consult with civil or geotechnical engineer for repair scope. At this time, no expectation of large scale repairs or replacement no Reserve funding recommended. An allowance for partial repairs/replacements may be added during future Reserve Study updates if warranted by association history.

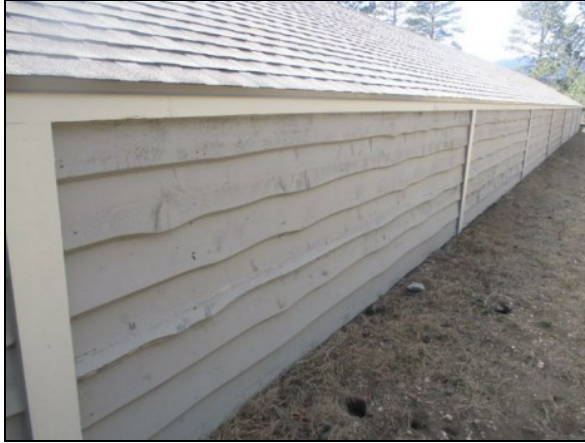
**Comp #: 21510 Carport Siding - Replace****Approx Quantity: 2,800 GSF****Location:** Common Areas**Funded?:** No.**History:****Comments:** Funding for this component is covered in the scope of work of the larger siding replacement projects for each residential buildings. Please refer to component # 23320 for more general information.**Useful Life:****Remaining Life:**

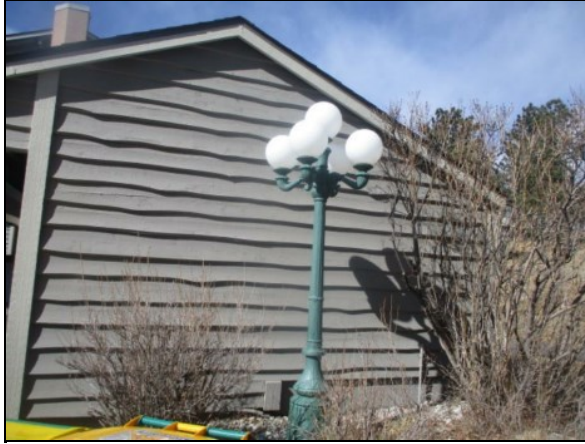
**Comments:** Pole lights determined to be in fair condition typically exhibit somewhat faded/worn appearance but overall assembly is sturdy and aging normally. Serviceable physical condition and still appropriate for aesthetic standards. Observed during daylight hours assumed to be in functional operating condition. As routine maintenance, inspect, repair/change bulbs as needed. Best to plan for large scale replacement for cost efficiency and consistent quality/appearance throughout Association.

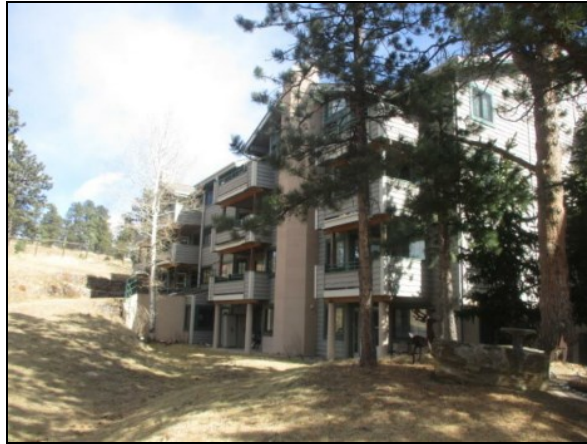
**Comments:** In general, costs related to this component are expected to be included in the Association's Operating budget. No recommendation for Reserve funding at this time. However, any repair and maintenance or other related expenditures should be tracked, and this component should be re-evaluated during future Reserve Study updates based on most recent information and data available at that time. If deemed appropriate for Reserve funding, component can be included in the funding plan at that time.

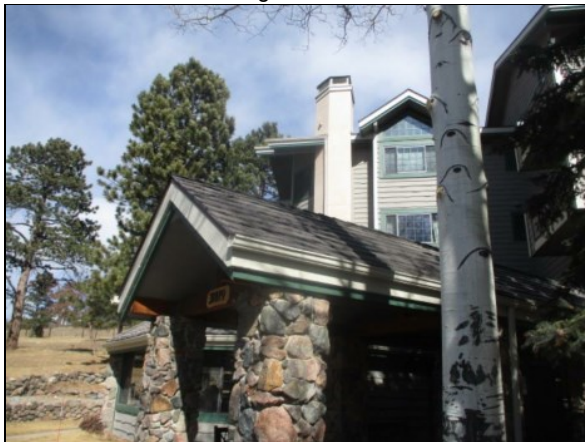
**Comments:** Client reported that the maintenance and repair of the heat tape is incorporated as-needed into an Association's Operating budget. No recommendation for Reserve funding at this time.

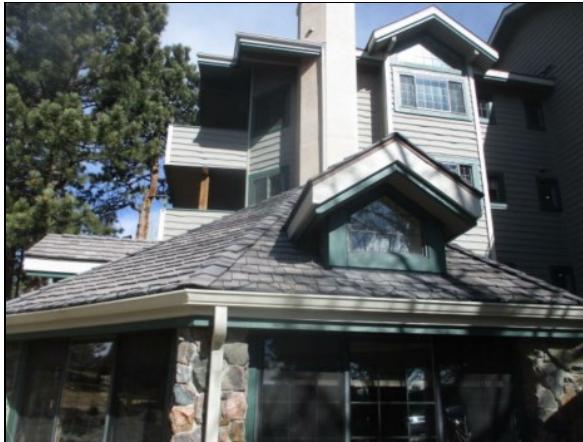
**Comments:** Client reported that the maintenance and repair of the heat tape is incorporated as-needed into an Association's Operating budget. No recommendation for Reserve funding at this time.

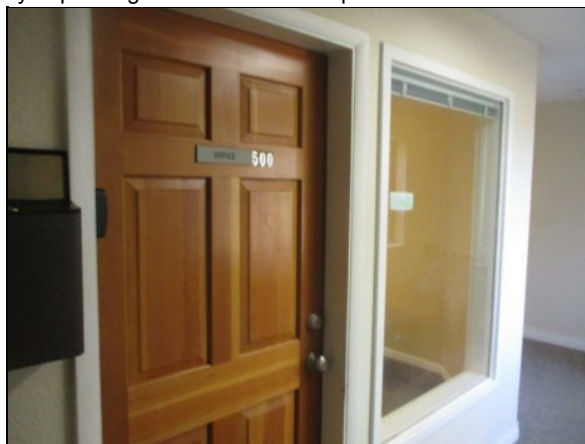
**Comments:** Includes (1) Haller mini fridge, (3) desks, (5) file cabinets, (1) printer and (1) desk. Office was observed to be in good condition. Flooring was clean and free of issues. Fixtures and equipment appeared to be in good condition. Periodic office remodeling is prudent in order to maintain an attractive, functional workspace for personnel. Typical projects often include replacement of room finishes and furnishings, and may also include replacement of IT equipment, office supplies, storage units, etc. Life estimates can vary greatly depending on level of use and preferences of the Association.
