## Rocky Mountain Village Estates *Evergreen, CO*

Report #: 8361-8  
Beginning: January 1, 2027  
Expires: December 31, 2027

# RESERVE STUDY Update "With-Site-Visit"

August 6, 2026

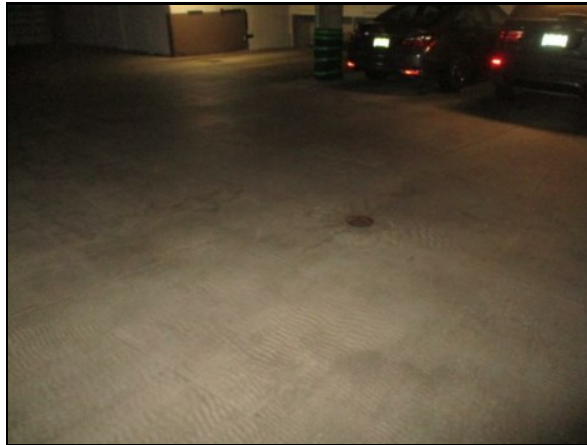
**Comp #:** 21010 Garage Concrete - Seal/Repair

**Remaining Life:**

2 years

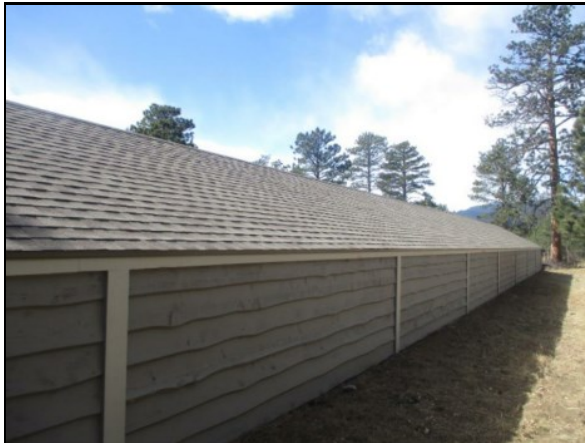
**Comments:** Funding for this component is covered in the scope of work of the larger siding painting projects for each residential buildings. Please refer to component # 23310 for more general information.

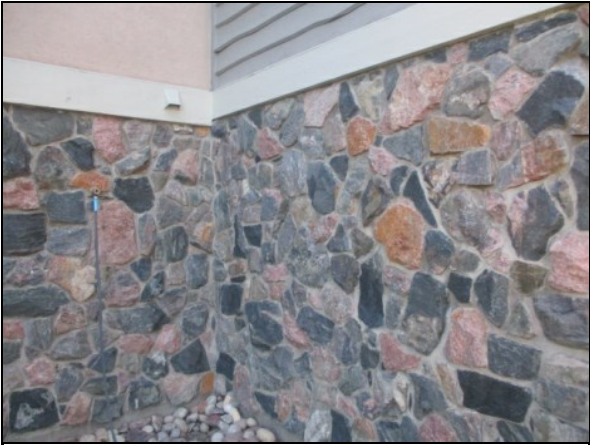
**Comp #: 23370 Stone Veneer - Maintain/Repair**

**Comments:** Brick or other masonry siding is typically a low maintenance surface that requires minimal, infrequent repair. However, in some cases (usually after several decades or more), the original mortar between bricks may require repointing to restore appearance and adequately protect against water intrusion. Repointing involves raking out a portion of the existing mortar and installing new mortar and continuing on until all affected sections have been replaced. In our experience, there is not a well-defined predictable timeline for repointing work, usually making this project inappropriate for Reserve funding. If re-pointing is a concern, we strongly recommend further inspection by a qualified engineer and/or masonry specialist to diagnose existing conditions and recommend a scope of work. If warranted, the Reserve Study can be adjusted to include funding recommendations going forward.

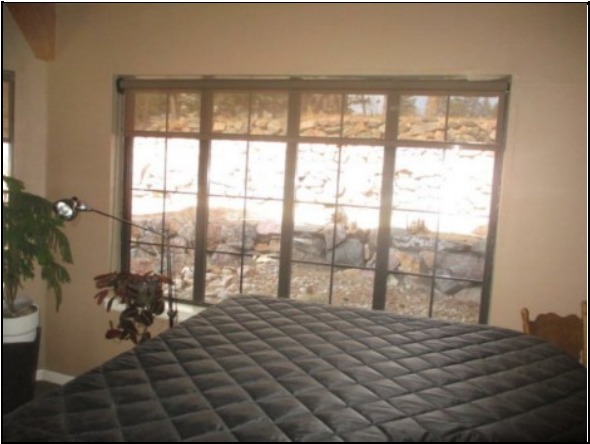
Comp #: 23440 Windows (Common) - Replace - 20%

Comments: Only includes common area windows in hallways and other common rooms. Client reportedly replaces windows on an on-going as needed basis. It was reported that the unit windows are the responsibility of the individual unit owner. Windows determined to be in fair condition typically exhibit normal signs of wear for their age, including more surface wear to framework and hardware, but no advanced corrosion or other concerns. At this stage, windows are believed to be functional and aging normally, but more advanced technology may be available. Inspect regularly, including sealant, if any, and repair as needed. Proper sealant/caulking is critical to keeping water out of the walls, and preventing water damage. With ordinary care and maintenance, useful life is long but difficult to predict. Many factors affect useful life including quality of window installed, waterproofing flashing details, exposure to wind driven rain. In many cases, windows are replaced on an ongoing basis to select areas as-needed rather than to an entire building at one time. This component should be re-evaluated as the building ages and more problems develop, and funding recommendations should be adjusted accordingly. An allowance for partial replacements may be warranted if certain windows are more deteriorated than others. Consult with vendors to ensure replacement windows are compliant with all applicable building codes. Note there are many types of windows available in today's market and costs can vary greatly.

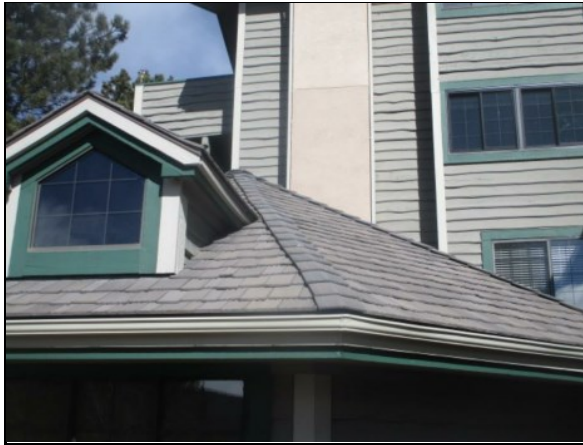
**Comp #: 23570 Roof: Composition Shingle - Replace**

**Comments:** Asphalt shingle roofs determined to be in fair condition and typically exhibit normal signs of wear and deterioration, such as minor loss of granule cover, and light to moderate curling/lifting, especially in more exposed areas. Overall believed to be aging normally. A Reserve Study conducts only a limited visual review, and many of the critical waterproofing and ventilation items of the roof are not readily viewable. For a full evaluation have a professional roof consultant/contractor perform a thorough up-close survey of your entire roof system, including attic inspection (if any). Costs below factors replacement with an architectural grade laminated shingle. As routine maintenance, many manufacturers recommend inspections at least twice annually (once in the fall before the snow season and again in the spring) and after large storm events. Promptly replace any damaged/missing sections or any other repair needed to ensure waterproof integrity of roof. Keep roof surface, gutters, and downspouts clear and free of debris. At the time of re-roofing, we recommend that you hire a professional consultant to evaluate the existing roof and specify the new roof materials/design, provide installation oversight. We recommend that all Associations hire qualified consultants whenever they are considering having work performed on any building envelope (waterproofing) components including: roof, walls, windows, decks, exterior painting, and caulking/sealant. There is a wealth of information available through Roofing Organizations such as: National Roofing Contractors Association (NRCA) <http://www.nrca.net>. Asphalt Roofing Manufacturers Association (ARMA) <http://www.asphaltroofing.org/> Roof Consultant Institute (RCI) <http://www.rci-online.org>

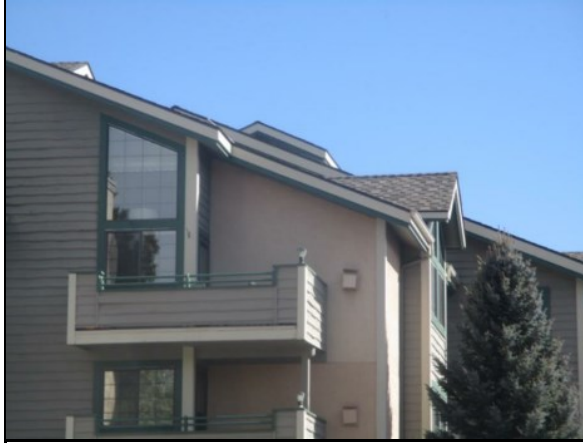
**Comp #: 23650 Gutters/Downspouts - Replace****Approx Quantity: 1,600 LF****Location:** Building Exteriors**Funded?:** Yes.**History:** Replaced in 2018

**Comments:** Gutters and downspouts determined to be in good condition typically exhibit little to no significant surface wear or deterioration of material. No obvious sagging or tilting sections. Attachments to building appear to be strong and stable. Gutters and downspouts appear to be functioning properly. As routine maintenance, inspect regularly, and keep gutters and downspouts free of debris. Repair or replace individual sections as needed as an Operating expense. We generally recommend that the gutters and downspouts be replaced when the roof is being resurfaced/replaced. National Roofing Contractor client (NRCA) roofing standard includes installing eave flashings at the gutters. We suggest to plan for total replacement of gutter and downspouts at the same intervals as roof replacement for cost efficiency. Unless otherwise noted, costs shown here assume replacement with similar type as are currently in place.

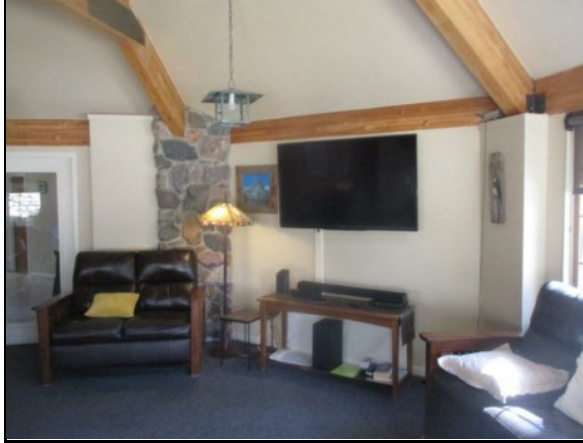
**Comments:** Includes 1st and Second Floors. Regular cycles of professional painting are recommended to maintain appearance. Small touch-up projects can be conducted as needed as a maintenance expense, but comprehensive painting of interior areas will restore a consistent look and quality to all areas. Best practice is to coordinate at same time as other interior projects (flooring, furnishings, lighting, etc.) whenever possible to minimize downtime and maintain consistent quality standard.

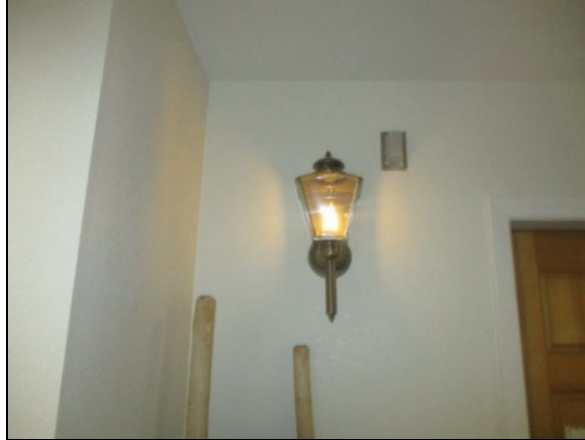
**Comp #: 24030 Interior Lights - Replace****Approx Quantity: 74 Fixtures****Location:** Interiors**Funded?:** Yes.**History:**

**Comments:** Interior wall lights were noted to be in fair condition with no significant damage/deterioration, although style may be consider outdated. As routine maintenance, inspect, repair and change bulbs as needed. Best practice is to coordinate at same time as other interior projects (especially painting) whenever possible to minimize downtime and maintain consistent quality standard. Timing of replacements is ultimately subjective. Estimates shown here are based on our experience with similar properties and general aesthetic qualities. A wide variety of fixture styles is available funding recommendations are based on replacement with comparable quality fixtures.

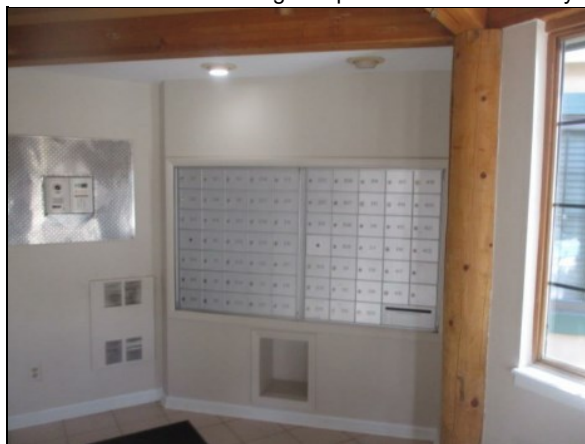
**Comp #: 24040 Mailboxes - Replace****Approx Quantity: 70 Boxes****Location:** Building Interiors**Funded?:** Yes.**History:**

**Comments:** Mailboxes determined to be in fair condition typically exhibit some amount of surface wear and/or rusting, but remain in serviceable and generally decent aesthetic condition. Clean and inspect regularly, change lock cylinders, lubricate hinges and repair as needed from Operating budget. Metal mailbox structures located inside protected interior areas can have very long life expectancies. In our experience, it is prudent to expect replacement at the approximate interval shown below in order to maintain good appearance consistent with other interior areas. Timing of replacements is ultimately subjective.

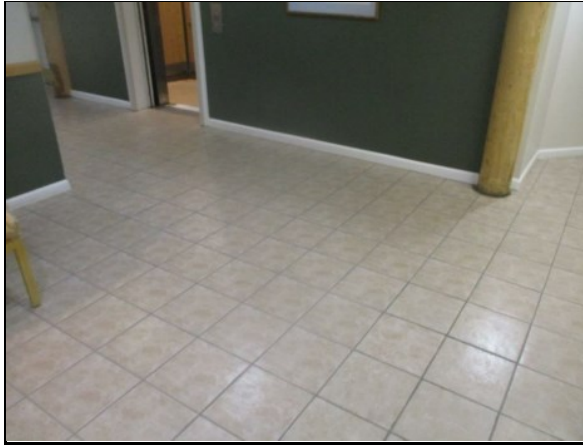
**Comp #: 24060 Tile Flooring - Replace****Approx Quantity: 660 GSF****Location:** Building Interiors**Funded?:** Yes.**History:**

**Comments:** Tiled surfaces were determined to be in fair condition. Floors did not exhibit any extensive un-even or broken sections. No evidence of heavy deterioration or broken tiles. As part of ongoing maintenance program, inspect regularly, repairing or replacing damaged sections as needed. If available, best practice is to keep a collection of replacement tiles on hand for partial replacements. With ordinary care and maintenance, tile in interior locations can last for an extended period of time, but replacement is often warranted eventually to enhance and restore aesthetic appeal in the common areas. Replacement costs can vary greatly depending on size and type of tiles selected. Our recommendation is to replace at the approximate schedule shown here, but this schedule can be adjusted at the association's discretion. "

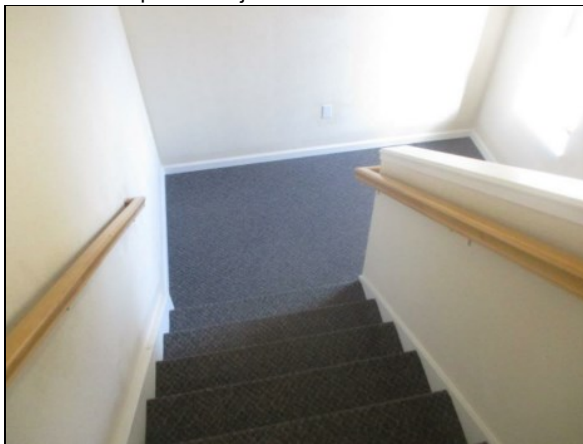
**Comp #: 24070 Stairwell Carpet - Replace****Approx Quantity: 3 Sets****Location:** Interiors**Funded?:** Yes.**History:** Replaced in 2006

**Comments:** No evidence of staining, matting, or loose seams observed. As part of ongoing maintenance program, vacuum regularly and professionally clean as needed. Best practice is to coordinate at same time as other interior projects whenever possible to minimize downtime and maintain consistent quality standard. Timing and interval is somewhat subjective, but not as flexible as other flooring finishes (tile, wood, etc.). Estimates shown here are based on our experience with similar properties and general aesthetic qualities. Schedule can be updated/adjusted at the discretion of the association for planning purposes.

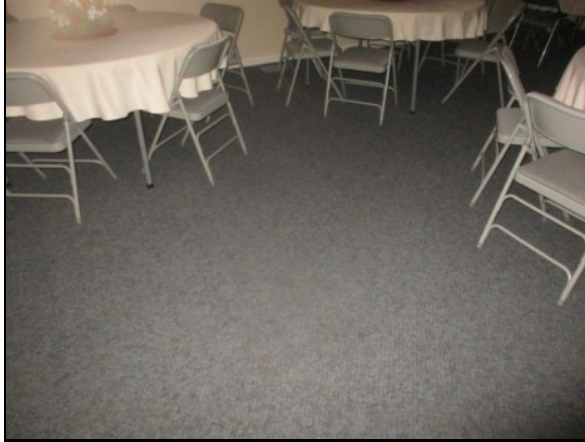
**Comp #: 24080 Carpeting - Replace - 1&2****Approx Quantity: 375 GSY****Location:** Interiors - 1st and 2nd floors**Funded?:** Yes.**History:** Replaced in 2025

**Comments:** Carpeted surfaces were determined to be in good condition. No evidence of staining, matting, or loose seams observed. As part of ongoing maintenance program, vacuum regularly and professionally clean as needed. Best practice is to coordinate at same time as other interior projects whenever possible to minimize downtime and maintain consistent quality standard. Timing and interval is somewhat subjective, but not as flexible as other flooring finishes (tile, wood, etc.). Estimates shown here are based on our experience with similar properties and general aesthetic qualities. Schedule can be updated/adjusted at the discretion of the client for planning purposes.

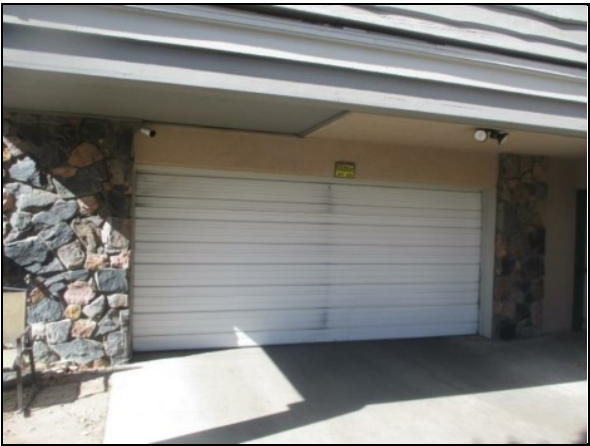
**Comp #: 25070 Garage Door - Replace**

**Comments:** We strongly recommend regular inspections, maintenance and repairs to help extend useful life cycles. Clean for appearance and paint/touch-up as needed as a general maintenance expense. In general, costs related to replacement of this component are expected to be included in the Association's Operating budget. No recommendation for Reserve funding at this time. However, any repair and maintenance or other related expenditures should be tracked, and this component should be re-evaluated during future Reserve Study updates based on most recent information and data available at that time. If deemed appropriate for Reserve funding, component can be included in the funding plan at that time.

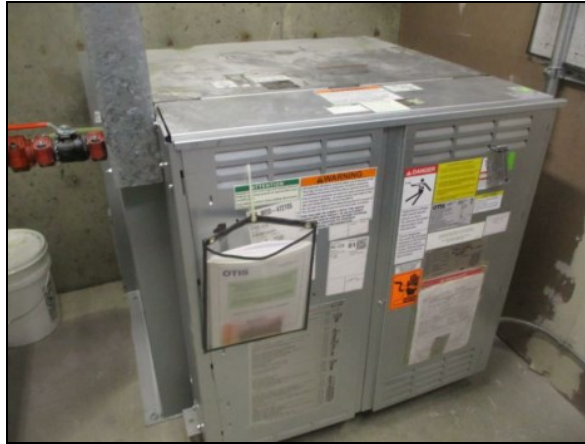
**Comments:** Elevators should be inspected regularly and tested as a preventive maintenance expense. This modernization project typically includes replacement/upgrade of controller(s), mechanical door components, push-button fixtures, and includes additional allowances for electrical work or fire alarm work by others, code-required changes, etc. Elevator vendors typically recommend modernization cycles of approximately 25 years for continued smooth, safe operation, technology advances and/or code changes. In our experience, actual interval is typically 20-30 years or sometimes longer, depending on level of use, maintenance, availability of replacement parts, etc. When remaining useful life is below 5 years, we recommend beginning discussions with your elevator vendor to determine the most cost effective specifications and approach to a modernization project. Modernization should be anticipated and planned for, as lead time for required parts can be months-long if done on short notice. To minimize elevator downtime, schedule the project ahead of time and consult with elevator vendor for more information. Some properties opt to hire an elevator consultant to draft a scope of work and oversee the process of obtaining estimates, and installation for compliance. Costs shown here may need to be re-evaluated depending on unpredictable electrical or fire safety code changes and should be monitored during future Reserve Study updates.

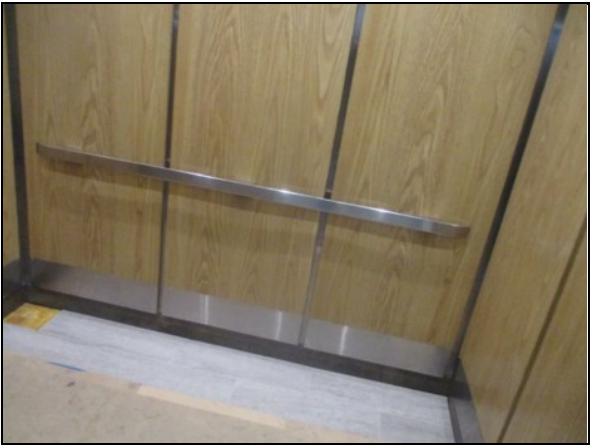
**Comments:** Elevator cabs determined to be in poor condition typically exhibit more advanced surface wear and physical deterioration and/or are no longer serving the aesthetic standards of the property. This component recommends budgeting for periodic remodeling of the elevator cab interior(s) to ensure good physical condition and maintain aesthetic standards of the property. Timing of this elective project is ultimately at the discretion of the client, but ideally should be coordinated with mechanical modernization to minimize downtime. Cost can vary greatly depending upon chosen design, and our estimates assume remodeling to a similar standard as currently in place. If higher quality standards are being considered, increases may need to be incorporated into future updates. A general allowance based upon our experience and consultation with elevator vendors is shown below for budgeting purposes, but any new information or cost estimates should be incorporated into future Reserve Study updates when known. Note if present, any service-only cabs are not expected to be a significant aesthetic priority and are not included here unless otherwise noted.

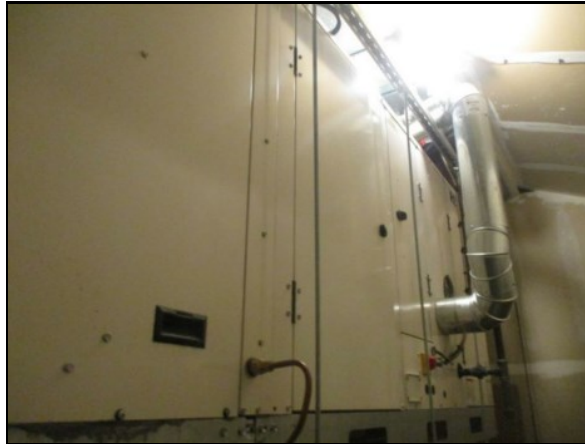
**Comp #: 25210 AHU Furnace - Replace****Approx Quantity: 1 Unit****Location:** Mechanical Room**Funded?:** Yes.**History:** Replaced in 2019

**Comments:** Includes (1) Reznor 250,000 BTU Unit (Model: HXE250-6-SMVJ; Serial: EARK66KIN59926MV4). Minimal or no subjective/aesthetic value for this component. Useful life is based primarily on normal expectations for service/performance life in this location. Unless otherwise noted, remaining useful life expectancy is based primarily on original installation or last replacement/purchase date, our experience with similar systems/components, and assuming normal amount of usage and good preventive maintenance. We recommend that routine repairs and maintenance such as filter replacements, system flushing, etc. be budgeted as an Operating expense. Useful life can often be extended with proactive service and maintenance. Unless otherwise noted, funding for system with same size/capacity as the current system. For split systems, we recommend budgeting to replace the entire system (condensing unit and air handler) together in order to obtain better unit pricing and ensure maximum efficiency, refrigerant compatibility, etc. If additional costs are expected during replacement, such as for system reconfiguration or expansion, ductwork repairs, electrical work, etc. costs should be re-evaluated and adjusted as needed during future Reserve Study updates.

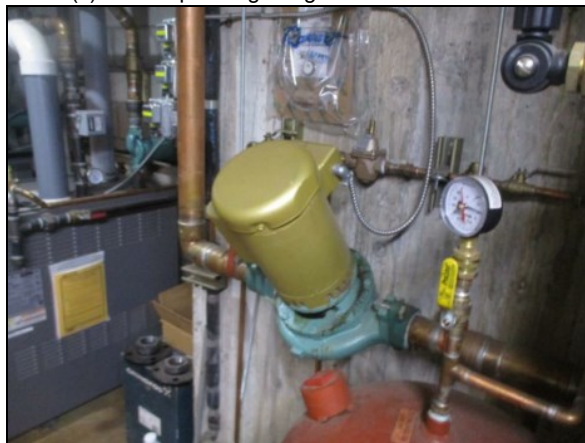
**Comp #: 25280 Pumps/Motors - Repair/Replace****Approx Quantity: 5 Pumps****Location:** Mechanical Room**Funded?:** Yes.**History:**

**Comments:** Expect eventual need for tear down and rebuild (more cost-effective than buying new units) at roughly the interval below. Treat smaller repair / replacement below the reserve funding threshold (< 1% of the annual operating expenses, excluding reserves) as general maintenance item(s) within operating budget.

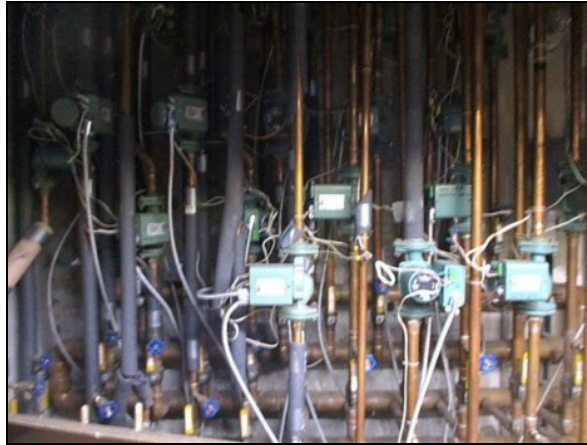
**Comp #: 25280 Pumps/Motors - Repair/Replace (Variable)****Approx Quantity: 24 Pumps****Location:** Mechanical Room**Funded?:** Yes.**History:** Client replaces the pumps as needed, typically 3 - 5 years, and keeps an extra supply on premises. These pumps are reported to last longer than those in the Genesee building.**Comments:** Includes (24) small Grundfos pumps. Please refer to the prior component in this series for more general information. Useful life, remaining useful life and cost ranges for this specific component are provided below.**Useful Life:**

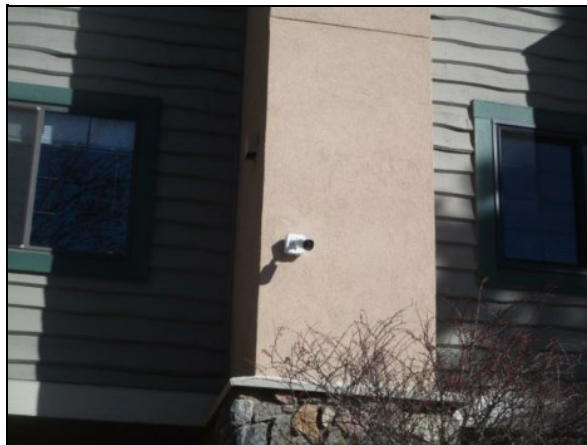
**Comp #: 25330 Surveillance System - Upgrade/Replace****Approx Quantity: 6 Cameras****Location:** Common Areas**Funded?:** Yes.**History:** Installed in 2023. (1) additional camera installed in 2025**Comments:** Minimal or no subjective/aesthetic value for this component. Useful life is based primarily on normal expectations for service/performance life in this location. Unless otherwise noted, remaining useful life expectancy is based primarily on original installation or last replacement/purchase date, our experience with similar systems/components, and assuming normal amount of usage and good preventive maintenance. Security/surveillance systems should be monitored closely to ensure proper function. Whenever possible, camera locations should be protected and isolated to prevent tampering and/or theft. Typical modernization projects may include addition and/or replacement of cameras, recording equipment, monitors, software, etc. Unless otherwise noted, costs assume that existing wiring can be re-used and only the actual cameras and other equipment will be replaced. In many cases, replacement or modernization is warranted due to advancement in technology, not necessarily due to functional failure of the existing system. Keep track of any partial replacements and include cost history during future Reserve Study updates.**Useful Life:**

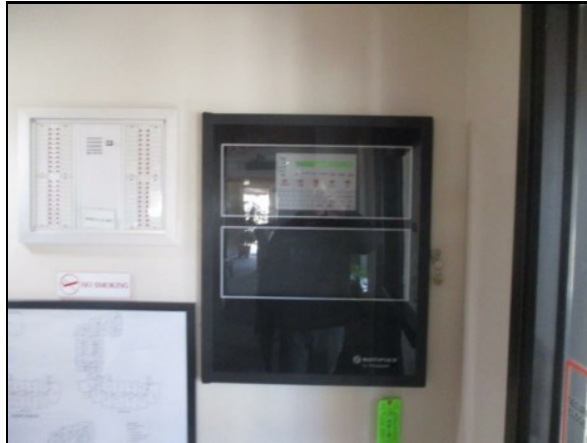
**Comp #: 25410 Fire Control Panel - Update/Replace****Approx Quantity: 1 Panel****Location:** Common Areas**Funded?:** Yes.**History:** Replaced in 2021

**Comments:** Panel is a Fire-Lite model. Our inspection is for planning and budgeting purposes only fire alarm equipment is assumed to have been designed and installed properly and is assumed to comply with all relevant building codes. Regular testing and inspections should be conducted as an Operating expense. In many cases, manufacturers discontinue support of equipment after a certain number of years, which may limit availability of replacement parts as the system ages. Cost estimates assume that existing wiring can be re-used and that only panel and devices will be replaced. If wiring requires replacement, estimates should be increased accordingly, but in our experience wiring should have an indefinite useful life. Cost estimates are based on quantity and type of existing equipment, not including any expansion or upgrades, which may be required. We recommend reviewing system components with fire alarm vendor on a regular basis. If expansion of system is found to be required, the Reserve Study should be updated and any additional costs should be factored accordingly.

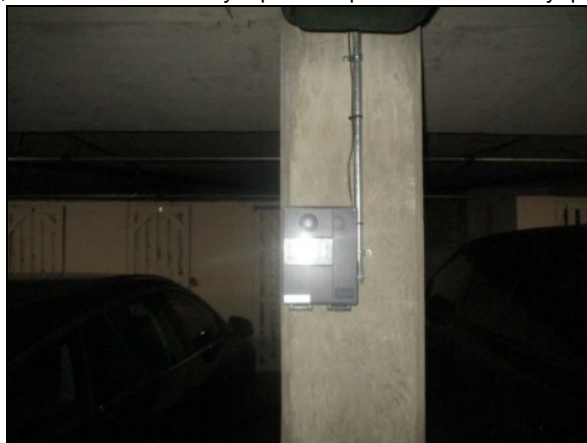
**Comp #: 25430 CO Monitors - Replace****Approx Quantity: 2 Monitors****Location:** Garage**Funded?:** No. Too small for Reserve designation - handle as an Operating expense.**History:**

**Comments:** Minimal or no subjective/aesthetic value for this component. In general, costs related to this component are expected to be handled through the client's Operating budget. Unless otherwise noted, remaining useful life expectancy is based primarily on original installation or last replacement/purchase date, our experience with similar systems/components, and assuming normal amount of usage and good preventive maintenance. Carbon monoxide monitors were not tested for functionality during site inspection. Should be inspected, tested and individually repaired/replaced as needed by qualified vendor.

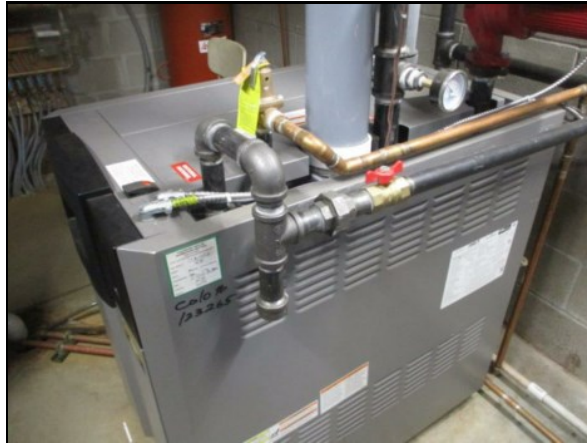
**Comp #: 25440 Boilers - Replace - DHW****Approx Quantity: 1 Unit****Location:** Mechanical Room**Funded?:** Yes.**History:** Replaced in 2013

**Comments:** Includes (1) Laars 500,000 BTU Unit (Model: G23576770; Serial: 576770). Minimal or no subjective/aesthetic value for this component. Useful life is based primarily on normal expectations for service/performance life in this location. Unless otherwise noted, remaining useful life expectancy is based primarily on original installation or last replacement/purchase date, our experience with similar systems/components, and assuming normal amount of usage and good preventive maintenance. With routine inspection and maintenance, the boiler should have an approximate useful life as shown below before replacement with future technology and efficiencies will be warranted. Life expectancy can vary based on level of use and location on the property. When considering replacements, the Association should strongly consider replacing with high-efficiency models. Although initial cost may be higher than conventional alternatives, the payback period in energy savings is often a fraction of the overall life span of the boiler itself. Costs to replace are based on replacement with same approximate size and capacity.

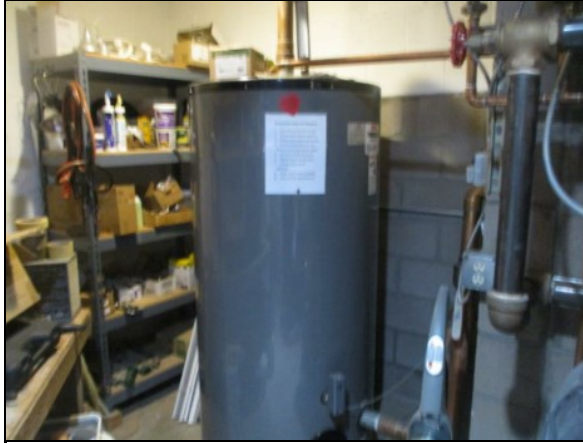
**Comp #: 25470 Water Storage Tanks - Replace**

**Comments:** Includes (1) Rheem 115 Gallon Tank (Model: ST120A 115; Serial: RR 0112D00472). Minimal or no subjective/aesthetic value for this component. Useful life is based primarily on normal expectations for service/performance life in this location. Unless otherwise noted, remaining useful life expectancy is based primarily on original installation or last replacement/purchase date, our experience with similar systems/components, and assuming normal amount of usage and good preventive maintenance. Hot water storage tanks should be inspected for leaks and other problems routinely by servicing vendor or maintenance staff. Small repairs and cleaning should be considered an Operating expense and conducted as needed. Plan to replace at the approximate interval shown below, ideally coordinated with replacement of the boiler/hot water heater itself in order to achieve better pricing and minimize system downtime.

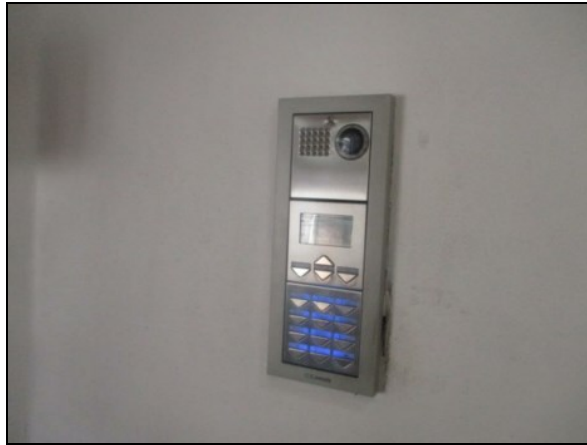
**Comp #:** 25010 Intercom/Entry System - Replace

**Comments:** Previous work on this component included substantial rewiring to update outdated system. Funding going forward is expected to only include the entry box itself. Access/intercom system was not inspected internally during site inspection. Should be checked and repaired as needed by servicing vendor as routine maintenance. Individual components can often be replaced for relatively low cost as an Operating expense. Plan for complete replacement at the approximate interval shown here for functional and aesthetic considerations.
