Update "With-Site-Visit" Reserve Study

Rocky Mountain Village Estates Evergreen, CO

Report #: 8361-2

Date Prepared: June 8, 2018

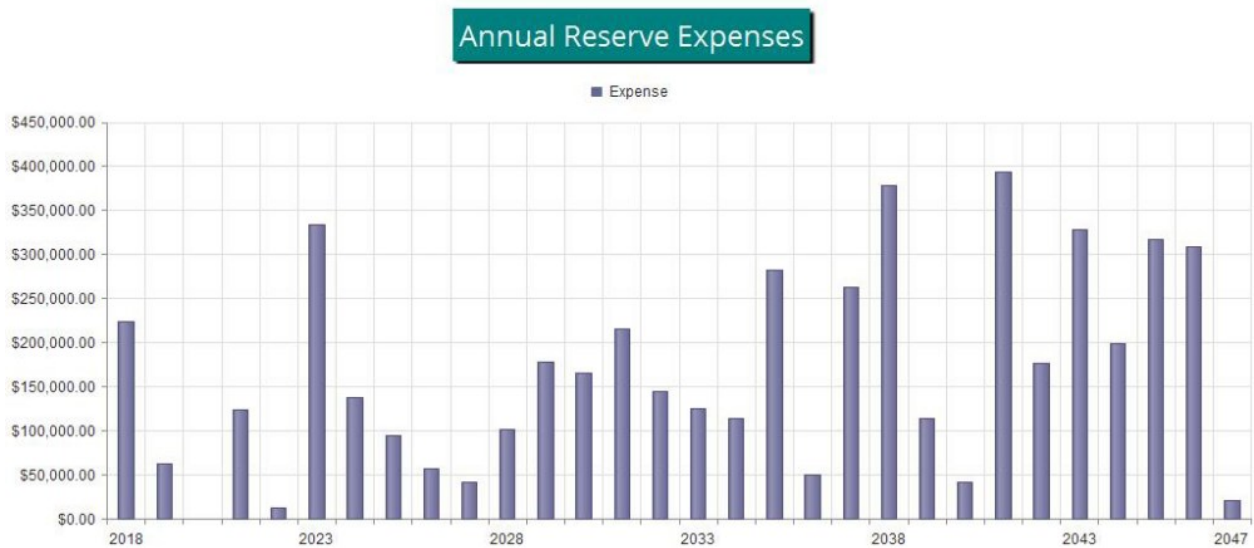
Figure 1

The figure below summarizes the projected future expenses as defined by your Reserve Component List. A summary of these expenses are shown in the 30-yr Summary Table, while details of the projects that make up these expenses are shown in the Cash Flow Detail Table.

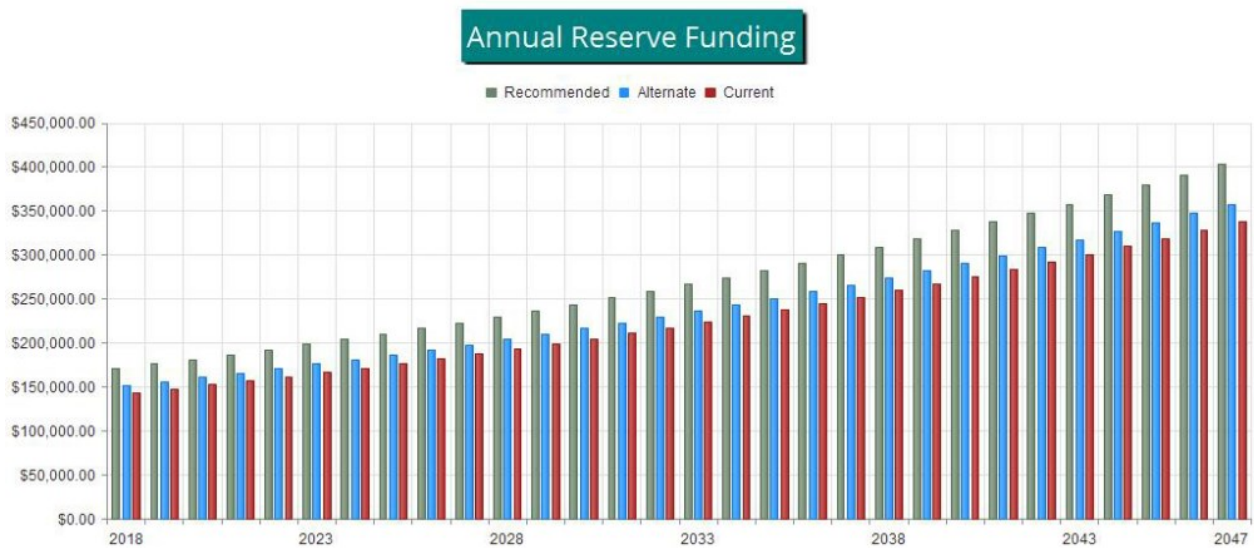
Figure 2

Based on your current Percent Funded and your near-term and long-term Reserve needs, we are recommending Monthly budgeted contributions of \$14,250. The overall 30-yr plan, in perspective, is shown below. This same information is shown numerically in both the 30-yr Summary Table and the Cash Flow Detail Table.

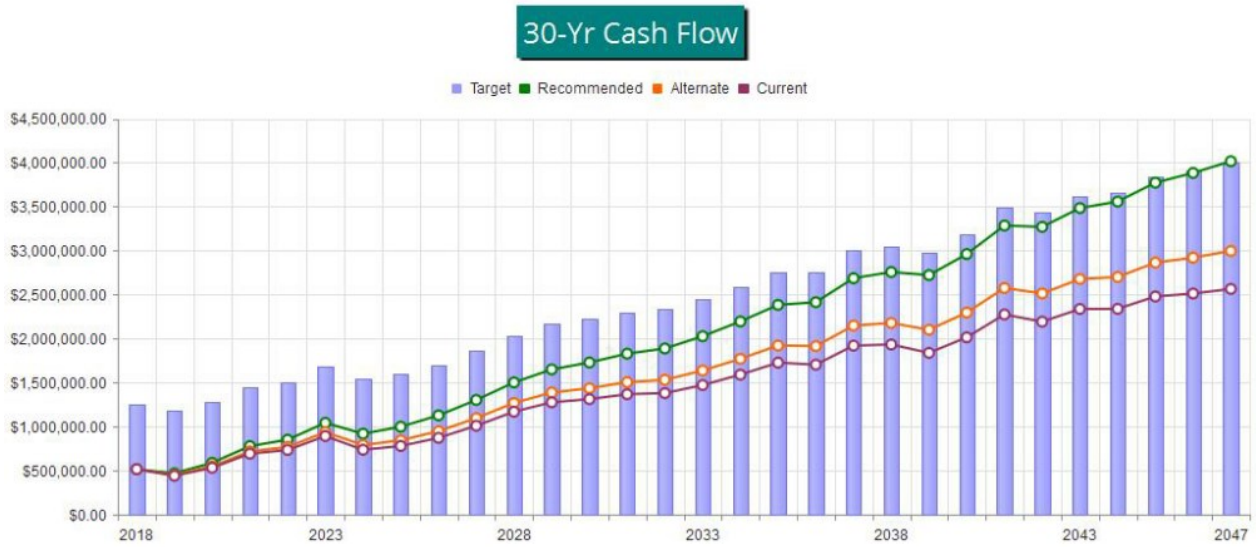
Figure 3

The following chart shows your Reserve balance under our recommended Full Funding Plan, an alternate Baseline Funding Plan, and at your current budgeted contribution rate, compared to your always-changing Fully Funded Balance target.

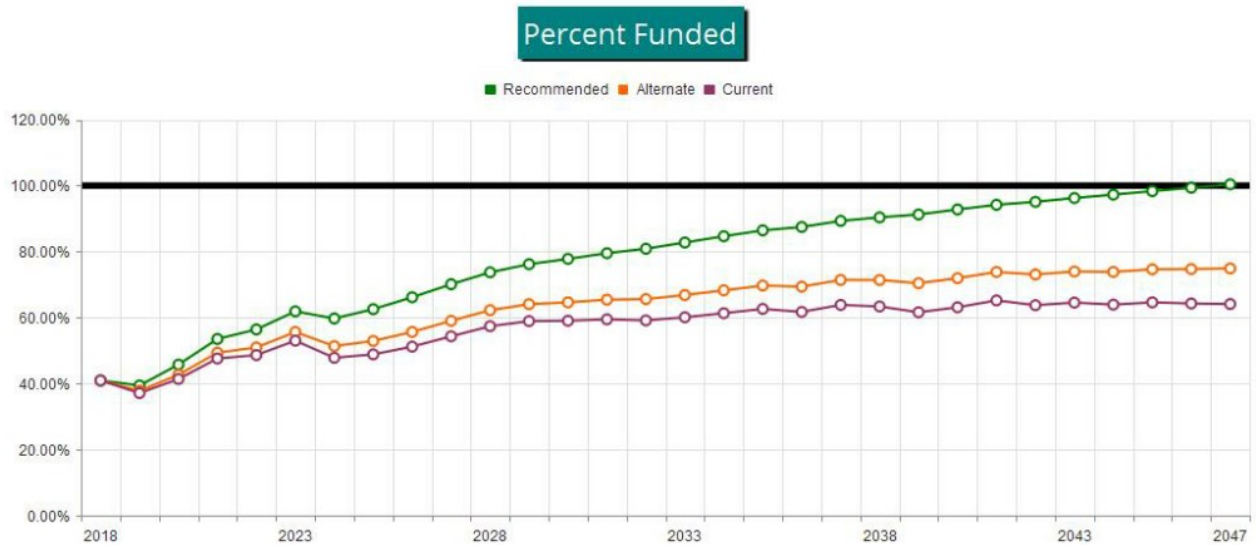
Figure 4

This figure shows the same information plotted on a Percent Funded scale. It is clear here to see how your Reserve Fund strength approaches the 100% Funded level under our recommended multi-yr Funding Plan.

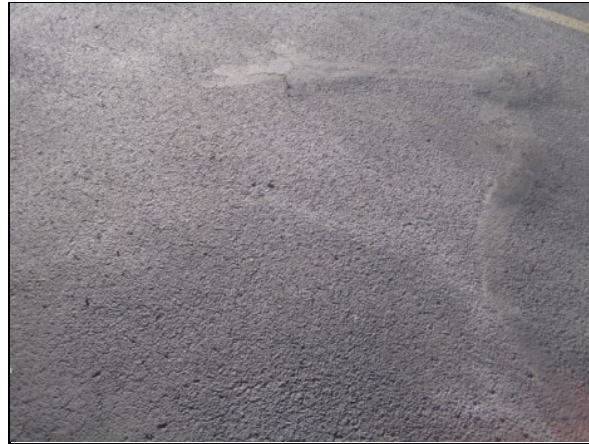
Useful Life:
4 years

Remaining Life:
7 years

Best Case: \$ 9,000

Worst Case: \$ 10,000

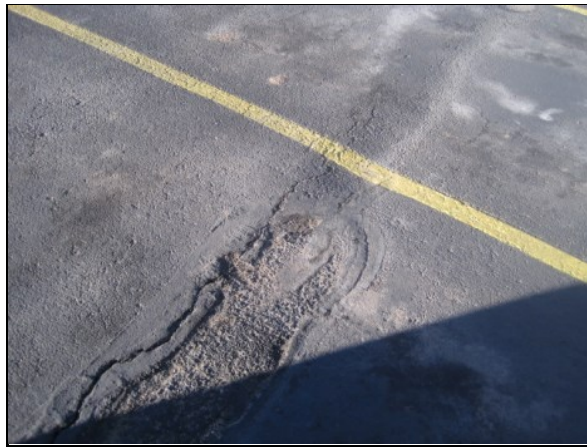
Useful Life:
25 years

Remaining Life:
3 years

Best Case: \$ 77,300

Worst Case: \$ 103,100

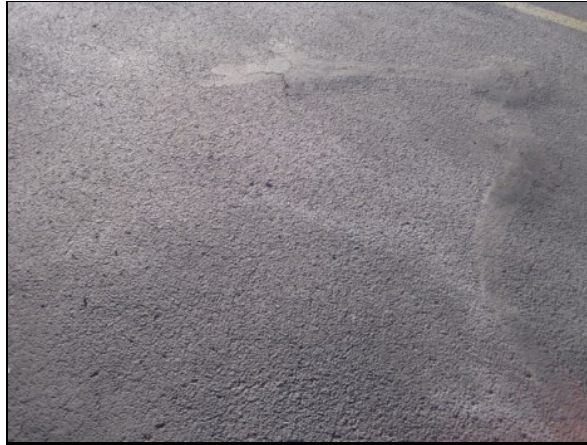
Useful Life:
4 years

Remaining Life:
7 years

Best Case: \$ 9,000

Worst Case: \$ 10,000

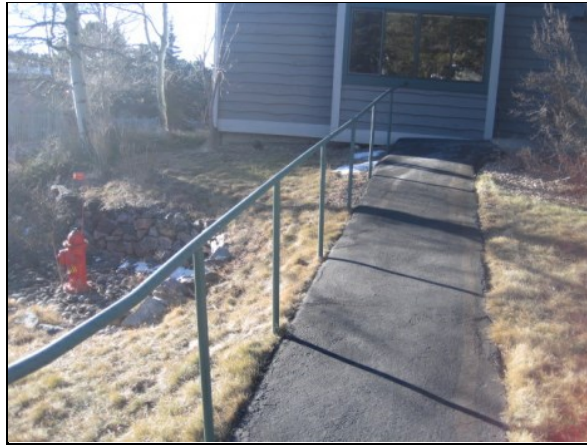
Useful Life:
30 years

Remaining Life:
10 years

Best Case: \$ 6,400

Worst Case: \$ 9,600

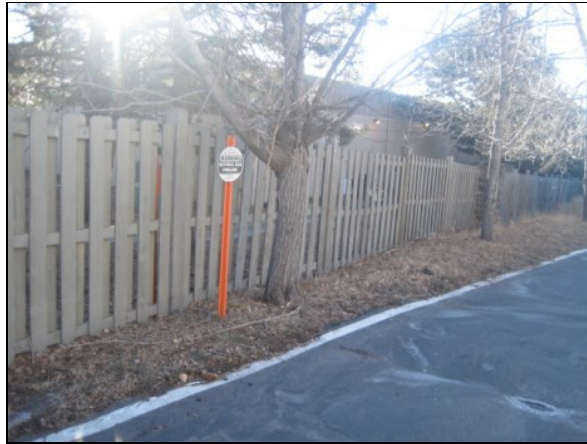
Useful Life:
25 years

Remaining Life:
5 years

Best Case: \$ 22,800

Worst Case: \$ 29,300

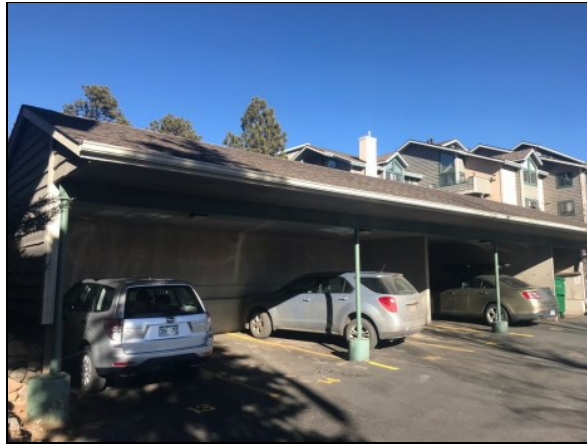
Useful Life:
25 years

Remaining Life:
0 years

Best Case: \$ 21,300

Worst Case: \$ 24,900

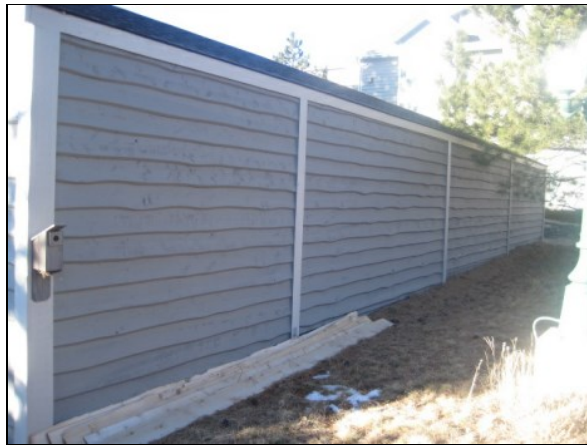
Useful Life:
5 years

Remaining Life:
0 years

Best Case: \$ 2,800

Worst Case: \$ 5,600

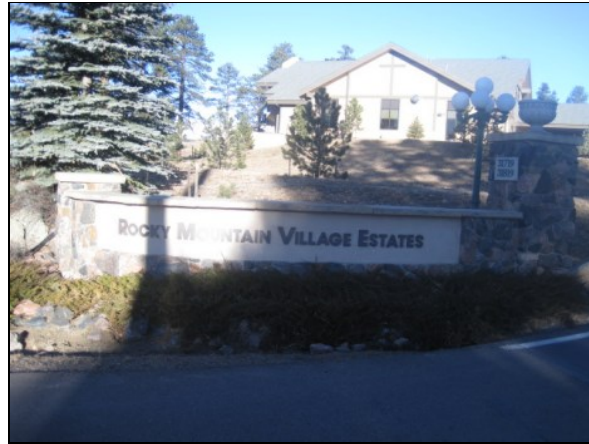
Useful Life:
10 years

Remaining Life:
9 years

Best Case: \$ 2,500

Worst Case: \$ 3,500

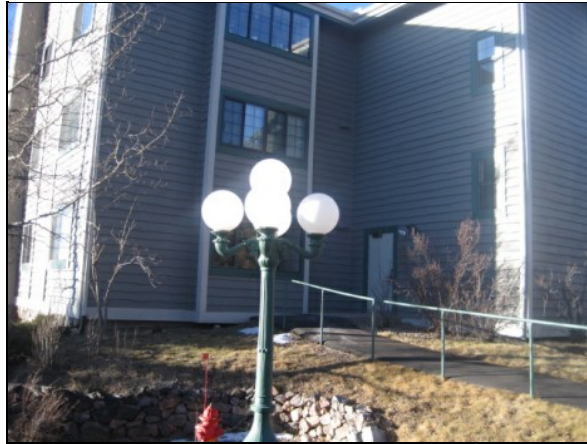
Useful Life:
30 years

Remaining Life:
5 years

Best Case: \$ 25,200

Worst Case: \$ 33,600

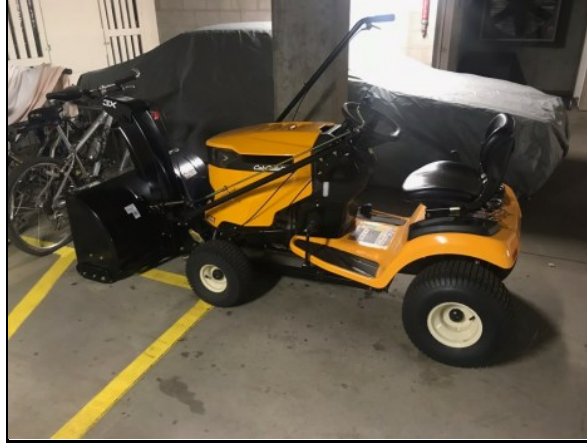
Useful Life:
12 years

Remaining Life:
11 years

Best Case: \$ 5,800

Worst Case: \$ 8,600

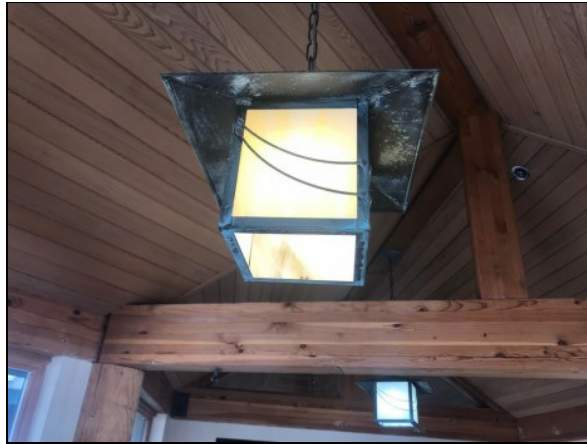
Useful Life:
25 years

Remaining Life:
0 years

Best Case: \$ 6,200

Worst Case: \$ 7,200

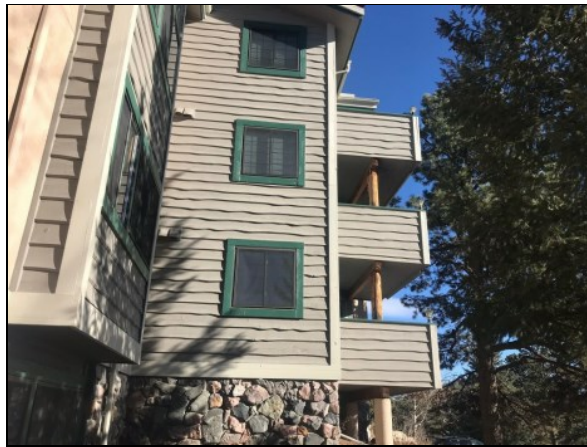
Useful Life:
7 years

Remaining Life:
5 years

Best Case: \$ 89,500

Worst Case: \$ 95,000

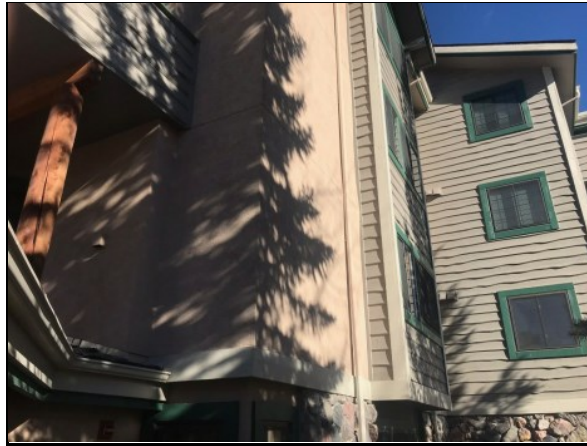
Useful Life:
15 years

Remaining Life:
9 years

Best Case: \$ 6,000

Worst Case: \$ 12,000

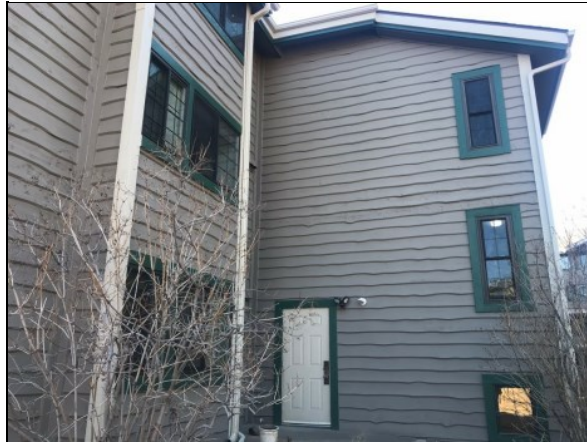
Useful Life:
60 years

Remaining Life:
35 years

Best Case: \$ 408,000

Worst Case: \$ 612,000

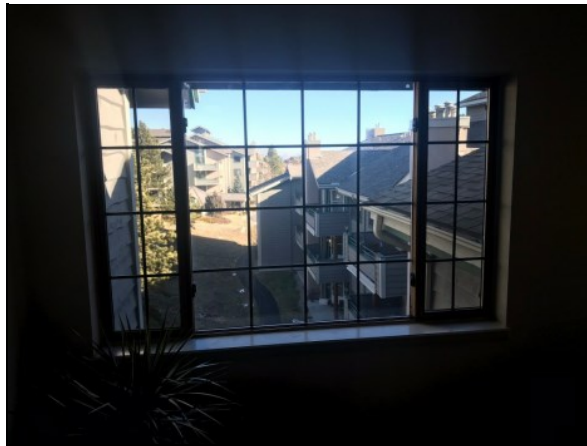
Useful Life:
5 years

Remaining Life:
4 years

Best Case: \$ 5,000

Worst Case: \$ 7,000

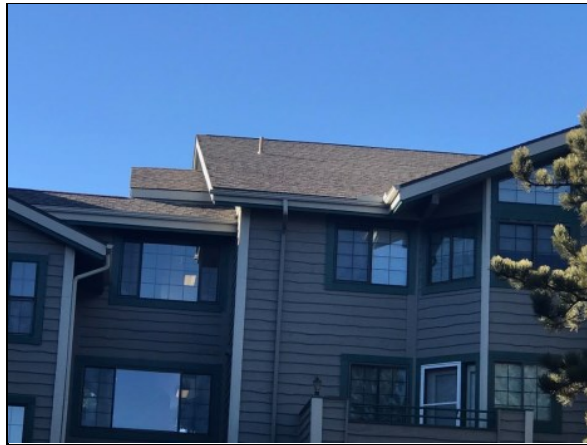
Useful Life:
25 years

Remaining Life:
17 years

Best Case: \$ 155,000

Worst Case: \$ 160,000

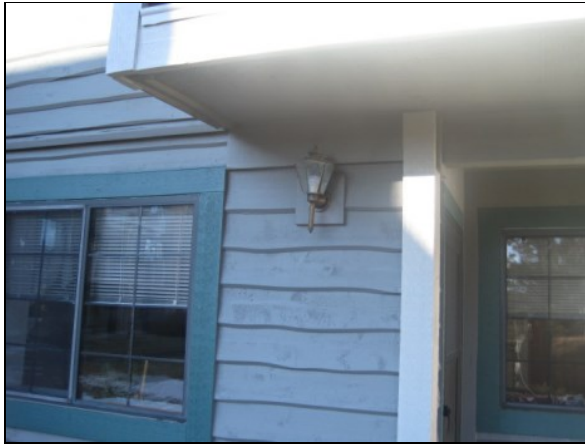
Useful Life:
25 years

Remaining Life:
0 years

Best Case: \$ 6,600

Worst Case: \$ 7,600

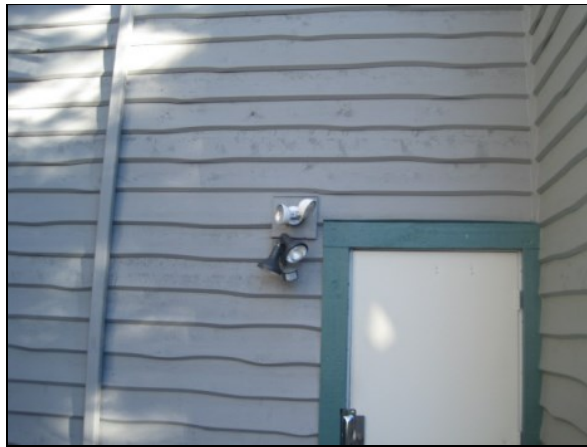
Useful Life:
7 years

Remaining Life:
6 years

Best Case: \$ 110,000

Worst Case: \$ 120,000

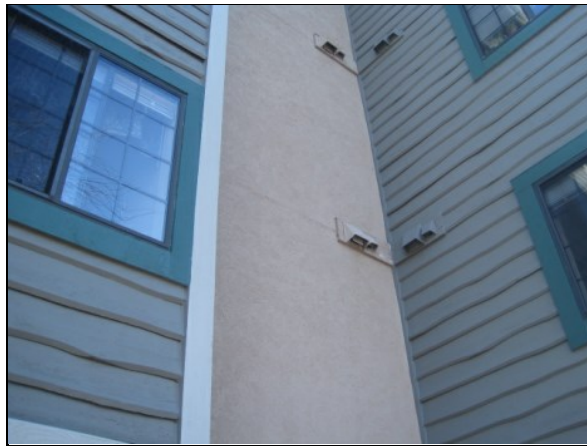
Useful Life:
15 years

Remaining Life:
9 years

Best Case: \$ 6,000

Worst Case: \$ 12,000

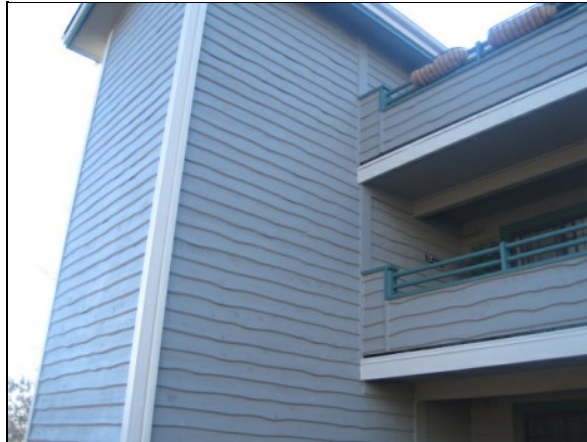
Useful Life:
60 years

Remaining Life:
37 years

Best Case: \$ 449,000

Worst Case: \$ 673,000

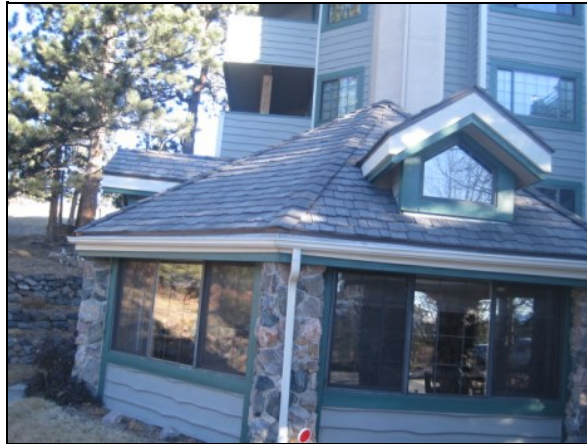
Comp #: 2361 Common Windows - Replace - 20%

Evaluation: Only includes common area windows in hallways and other common rooms. It was reported that the unit windows are the responsibility of the individual unit owner. Windows determined to be in fair condition typically exhibit normal signs of wear for their age, including more surface wear to framework and hardware, but no advanced corrosion or other concerns. At this stage, windows and doors are believed to be functional and aging normally, but more advanced technology may be available. Inspect regularly, including sealant, if any, and repair as needed. Proper sealant/caulking is critical to keeping water out of the walls, and preventing water damage. With ordinary care and maintenance, useful life is long but difficult to predict. Many factors affect useful life including quality of window installed, waterproofing flashing details, exposure to wind driven rain. In many cases, windows are replaced on an ongoing basis to select areas as-needed rather than to an entire building at one time. This component should be re-evaluated as the building ages and more problems develop, and funding recommendations should be adjusted accordingly. An allowance for partial replacements may be warranted if certain windows are more deteriorated than others. Consult with vendors to ensure replacement windows are compliant with all applicable building codes. Note there are many types of windows available in today's market and costs can vary greatly.

Useful Life:
30 years

Remaining Life:
5 years

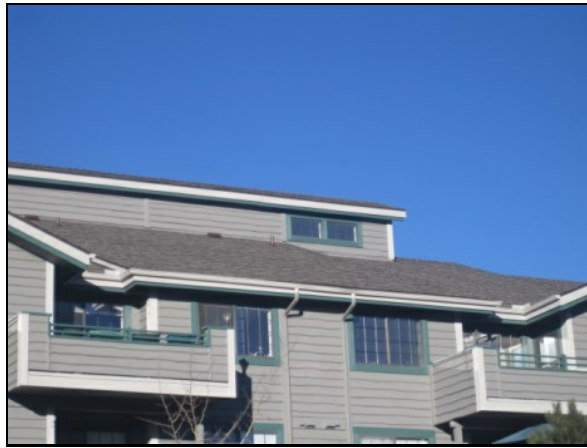
Comp #: 2377 Roof: Composition Shingle - Replace

History: Replaced in 2016

Evaluation: Asphalt shingle roofs determined to be in fair condition and typically exhibit normal signs of wear and deterioration, including some loss of granule cover, and light to moderate curling/lifting, especially in most exposed areas. Overall believed to be aging normally. A reserve study conducts only a limited visual review, and many of the critical waterproofing and ventilation items of the roof are not readily viewable. For a full evaluation have a professional roof consultant/contractor perform a thorough up-close survey of your entire roof system, including attic inspection (if any). Costs below factors replacement with an architectural grade laminated shingle. As routine maintenance, many manufacturers recommend inspections at least twice annually (once in the fall before the snow season and again in the spring) and after large storm events. Promptly replace any damaged/missing sections or any other repair needed to ensure waterproof integrity of roof. Keep roof surface, gutters, and downspouts clear and free of debris. At the time of re-roofing, we recommend that you hire a professional consultant to evaluate the existing roof and specify the new roof materials/design, provide installation oversight. We recommend that all Associations hire qualified consultants whenever they are considering having work performed on any building envelope (waterproofing) components including: roof, walls, windows, decks, exterior painting, and caulking/sealant. There is a wealth of information available through Roofing Organizations such as: National Roofing Contractors Association (NRCA) <http://www.nrca.net>. Asphalt Roofing Manufacturers Association (ARMA) <http://www.asphaltroofing.org/> Roof Consultant Institute (RCI) <http://www.rci-online.org>

Useful Life:
25 years

Remaining Life:
23 years

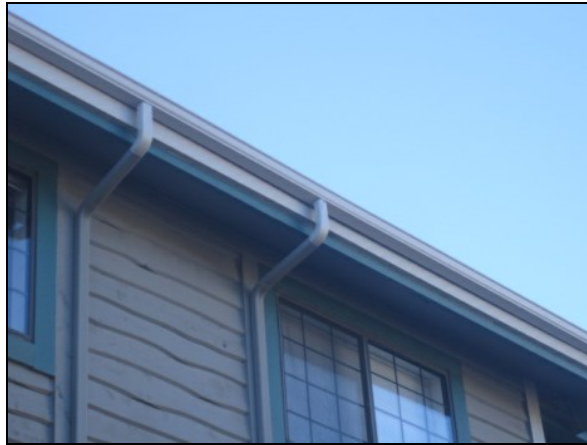
Comp #: 2387 Gutters/Downspouts - Replace

Evaluation: As routine maintenance, inspect regularly, keep gutters and downspouts free of debris. If buildings are located near trees, keep trees trimmed back to avoid accumulation of leaves on the roof surface which will accumulate in the gutters and increase maintenance requirements while reducing life expectancy. In general, costs related to this component are expected to be included in the Association's Operating budget. No recommendation for Reserve funding at this time. However, any repair and maintenance or other related expenditures should be tracked, and this component should be re-evaluated during future Reserve Study updates based on most recent information and data available at that time. If deemed appropriate for Reserve funding, component can be included in the funding plan at that time.

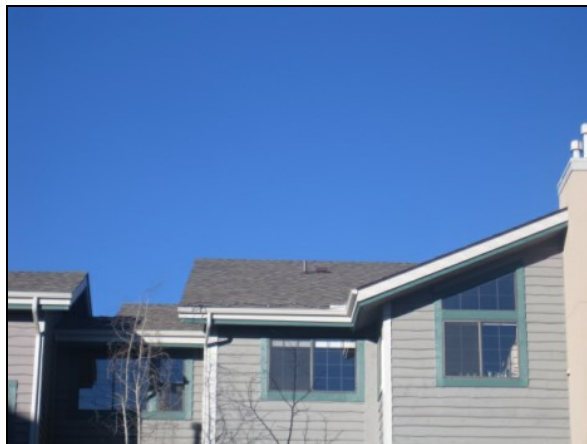
Comp #: 2389 Heat Tape - Replace

Evaluation: Client reported that the maintenance and repair of the heat tape is incorporated as-needed into an Association's Operating budget, or included as an add-on cost to roof replacement or maintenance projects. No recommendation for Reserve funding at this time.

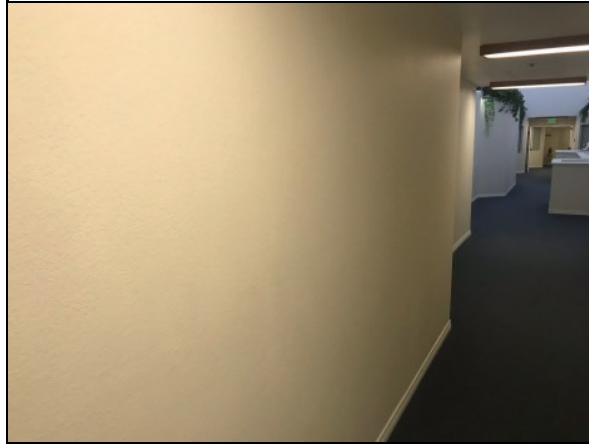
Evaluation: Includes 1st and Second Floors. Client reported that the interiors are painted annually. Regular cycles of professional painting are recommended to maintain appearance. Small touch-up projects can be conducted as needed as a maintenance expense, but comprehensive painting of interior areas will restore a consistent look and quality to all areas. Best practice is to coordinate at same time as other interior projects (flooring, furnishings, lighting, etc.) whenever possible to minimize downtime and maintain consistent quality standard.

Useful Life:
10 years

Remaining Life:
0 years

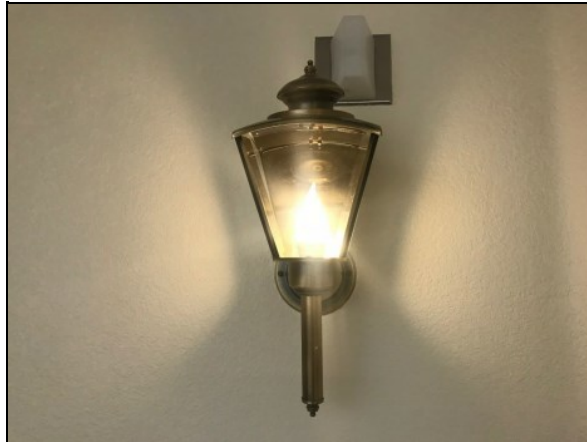
Comp #: 2405 Interior Lights - Replace

Evaluation: Interior wall lights were noted to be in fair condition with no significant damage/deterioration observed or reported to us. As routine maintenance, inspect, repair and change bulbs as needed. Best practice is to coordinate at same time as other interior projects (especially painting) whenever possible to minimize downtime and maintain consistent quality standard. Timing of replacements is ultimately subjective. Estimates shown here are based on our experience with similar properties and general aesthetic qualities. A wide variety of fixture styles is available funding recommendations are based on replacement with comparable quality fixtures.

Useful Life:
30 years

Remaining Life:
5 years

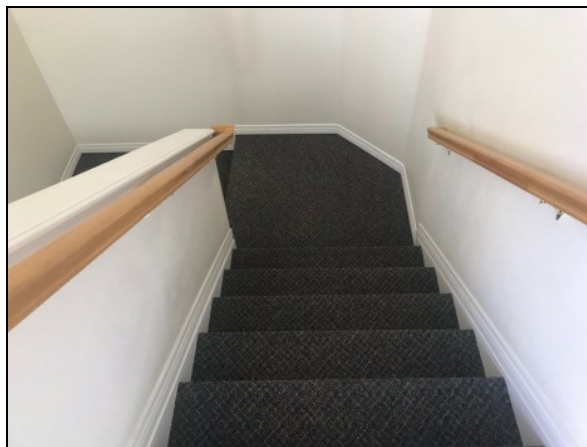
History: Replaced in 2006

Evaluation: Minor evidence of staining, matting, or loose seams observed. As part of ongoing maintenance program, vacuum regularly and professionally clean as needed. Best practice is to coordinate at same time as other interior projects whenever possible to minimize downtime and maintain consistent quality standard. Timing and interval is somewhat subjective, but not as flexible as other flooring finishes (tile, wood, etc.). Estimates shown here are based on our experience with similar properties and general aesthetic qualities. Schedule can be updated/adjusted at the discretion of the association for planning purposes.

Useful Life:
20 years

Remaining Life:
8 years

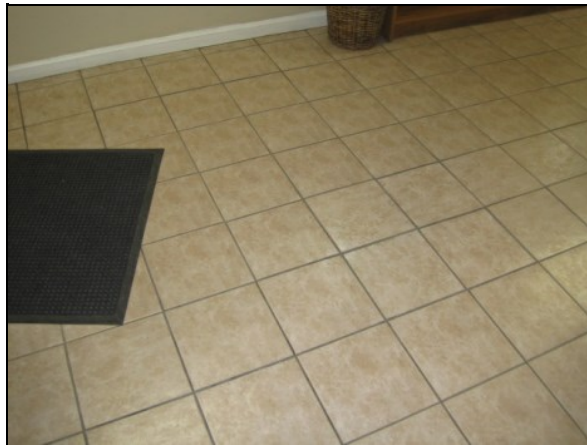
Comp #: 2409 Tile Flooring - Replace

Evaluation: Tile surfaces will need to be replaced ahead of schedule due to an unavailability of matching replacement tile. Tiled surfaces were determined to be in fair condition. Floors did not exhibit any extensive un-even or broken sections. No evidence of heavy deterioration or broken tiles. As part of ongoing maintenance program, inspect regularly, repairing or replacing damaged sections as needed. If available, best practice is to keep a collection of replacement tiles on hand for partial replacements. With ordinary care and maintenance, tile in interior locations can last for an extended period of time, but replacement is often warranted eventually to enhance and restore aesthetic appeal in the common areas. Replacement costs can vary greatly depending on size and type of tiles selected. Our recommendation is to replace at the approximate schedule shown here, but this schedule can be adjusted at the association's discretion. "

Useful Life:
50 years

Remaining Life:
3 years

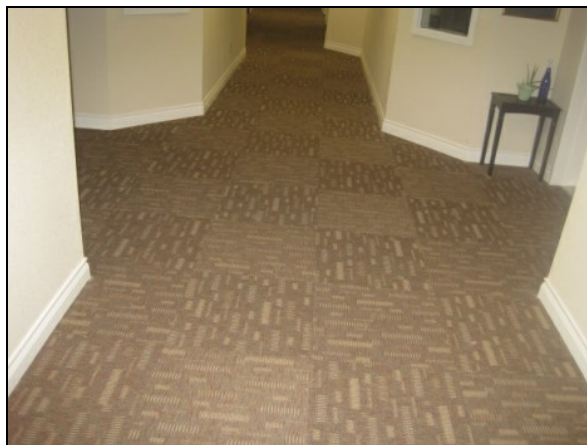
Comp #: 2411 Carpet - Replace - 1&2

Evaluation: Minor evidence of staining, matting, or loose seams observed. As part of ongoing maintenance program, vacuum regularly and professionally clean as needed. Best practice is to coordinate at same time as other interior projects whenever possible to minimize downtime and maintain consistent quality standard. Timing and interval is somewhat subjective, but not as flexible as other flooring finishes (tile, wood, etc.). Estimates shown here are based on our experience with similar properties and general aesthetic qualities. Schedule can be updated/adjusted at the discretion of the association for planning purposes.

Useful Life:
10 years

Remaining Life:
1 years

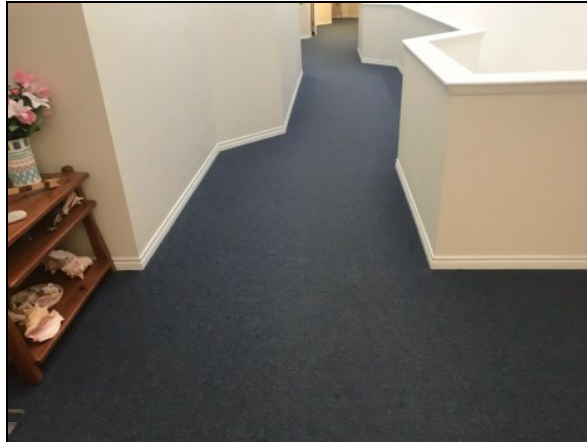
Comp #: 2411 Carpet - Replace - 3

Evaluation: Minor evidence of staining, matting, or loose seams observed. As part of ongoing maintenance program, vacuum regularly and professionally clean as needed. Best practice is to coordinate at same time as other interior projects whenever possible to minimize downtime and maintain consistent quality standard. Timing and interval is somewhat subjective, but not as flexible as other flooring finishes (tile, wood, etc.). Estimates shown here are based on our experience with similar properties and general aesthetic qualities. Schedule can be updated/adjusted at the discretion of the association for planning purposes.

Useful Life:
10 years

Remaining Life:
5 years

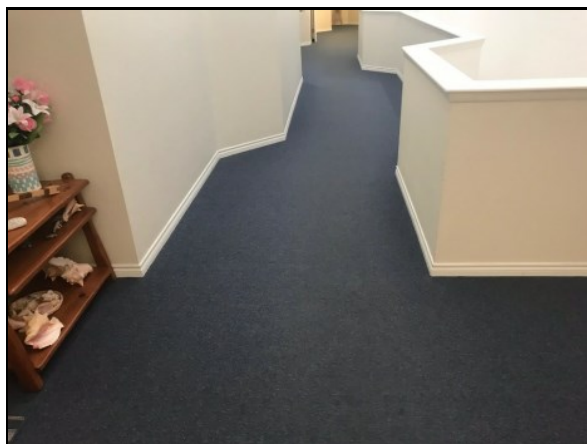
Comp #: 2411 Carpet - Replace - 4

Evaluation: Minor evidence of staining, matting, or loose seams observed. As part of ongoing maintenance program, vacuum regularly and professionally clean as needed. Best practice is to coordinate at same time as other interior projects whenever possible to minimize downtime and maintain consistent quality standard. Timing and interval is somewhat subjective, but not as flexible as other flooring finishes (tile, wood, etc.). Estimates shown here are based on our experience with similar properties and general aesthetic qualities. Schedule can be updated/adjusted at the discretion of the association for planning purposes.

Useful Life:
10 years

Remaining Life:
0 years

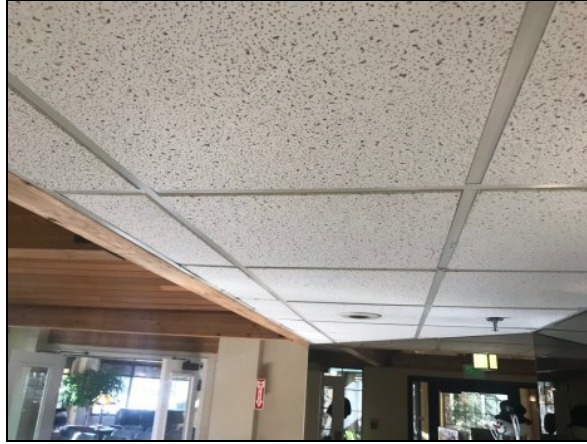
Comp #: 2419 Ceiling Panels - Replace

Evaluation: In general, costs related to this component are expected to be included in the Association's Operating budget. No recommendation for Reserve funding at this time. However, any repair and maintenance or other related expenditures should be tracked, and this component should be re-evaluated during future Reserve Study updates based on most recent information and data available at that time. If deemed appropriate for Reserve funding, component can be included in the funding plan at that time.

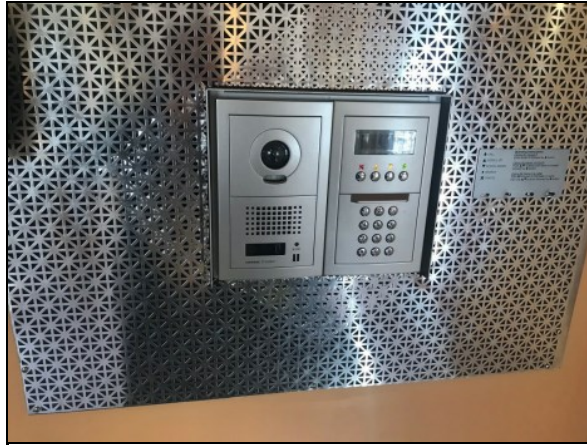
Comp #: 2501 Intercom/Entry System - Replace

History: Replaced in 2015

Evaluation: Previous work on this component included substantial rewiring to update outdated system. Funding going forward is expected to only include the entry box itself. Access/intercom system was not inspected internally during site inspection. Should be checked and repaired as needed by servicing vendor as routine maintenance. Individual components can often be replaced for relatively low cost as an Operating expense. Plan for complete replacement at the approximate interval shown here for functional and aesthetic considerations.

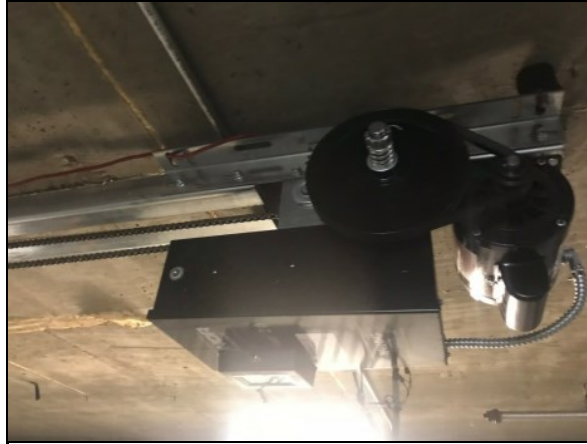
Comp #: 2505 Gate Operator - Replace

Evaluation: Raynor control hoist 2.0 model CST211SS serial # 2685344 1/2 hp. Minimal or no subjective/aesthetic value for this component. Useful life is based primarily on normal expectations for service/performance life in this location. Unless otherwise noted, remaining useful life expectancy is based primarily on original installation or last replacement/purchase date, our experience with similar systems/components, and assuming normal amount of usage and good preventive maintenance. We recommend regular inspections (including service and repair as needed) be paid through the Operating budget. Monitor actual expenses closely for future Reserve Study updates. In general, costs related to this component are expected to be included in the Association's Operating budget. No recommendation for Reserve funding at this time. However, any repair and maintenance or other related expenditures should be tracked, and this component should be re-evaluated during future Reserve Study updates based on most recent information and data available at that time. If deemed appropriate for Reserve funding, component can be included in the funding plan at that time.

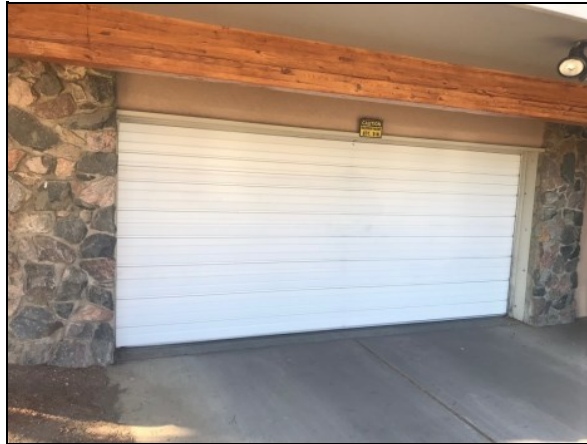
Comp #: 2506 Garage Door - Replace

Evaluation: We strongly recommend regular inspections, maintenance and repairs to help extend useful life cycles. Clean for appearance and paint/touch-up as needed as a general maintenance expense. In general, costs related to replacement of this component are expected to be included in the Association's Operating budget. No recommendation for Reserve funding at this time. However, any repair and maintenance or other related expenditures should be tracked, and this component should be re-evaluated during future Reserve Study updates based on most recent information and data available at that time. If deemed appropriate for Reserve funding, component can be included in the funding plan at that time.

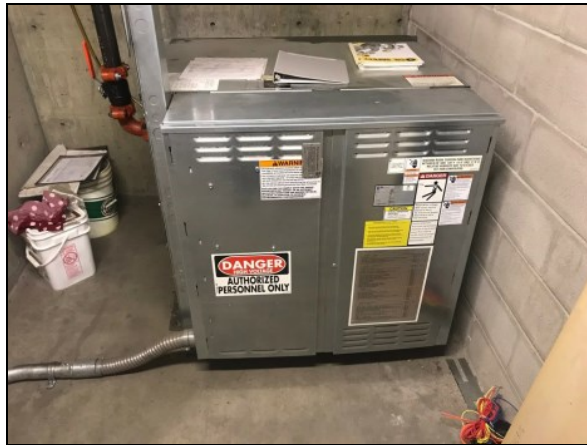
Evaluation: Client Requested this component be broken down into 4 components to reduce downtime of a single repair, this method has significantly higher life cycle cost. Otis ABA21241U model serial number 19720708. Elevators should be inspected regularly and tested as a preventive maintenance expense. This modernization project typically includes replacement/upgrade of controller(s), mechanical door components, push-button fixtures, and includes additional allowances for electrical work or fire alarm work by others, code-required changes, etc. Elevator vendors typically recommend modernization cycles of approximately 25 years for continued smooth, safe operation, technology advances and/or code changes. In our experience, actual interval is typically 20-30 years or sometimes longer, depending on level of use, maintenance, availability of replacement parts, etc. When remaining useful life is below 5 years, we recommend beginning discussions with your elevator vendor to determine the most cost effective specifications and approach to a modernization project. Modernization should be anticipated and planned for, as lead time for required parts can be months-long if done on short notice. To minimize elevator downtime, schedule the project ahead of time and consult with elevator vendor for more information. Some properties opt to hire an elevator consultant to draft a scope of work and oversee the process of obtaining estimates, and installation for compliance. Costs shown here may need to be re-evaluated depending on unpredictable electrical or fire safety code changes and should be monitored during future Reserve Study updates.

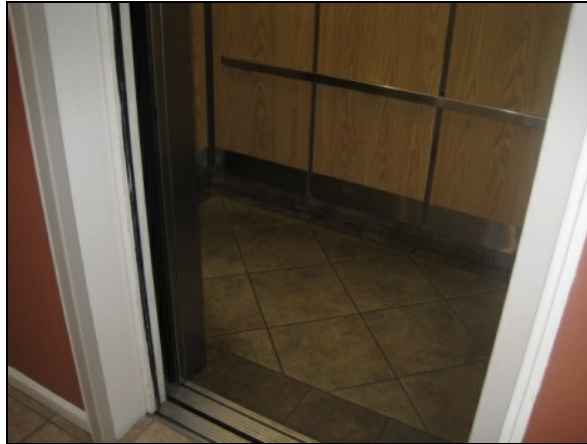
Evaluation: Elevator cabs determined to be in fair condition typically exhibit normal signs of wear and age, such as scuffing and surface wear to flooring and wall paneling, but remain generally clean and without any signs of advanced wear or damage. At this stage, aesthetic standards are still being upheld and cabs are aging normally overall. This component recommends budgeting for periodic remodeling of the elevator cab interior(s) to ensure good physical condition and maintain aesthetic standards of the property. Timing of this elective project is ultimately at the discretion of the client, but ideally should be coordinated with mechanical modernization to minimize downtime. Cost can vary greatly depending upon chosen design, and our estimates assume remodeling to a similar standard as currently in place. If higher quality standards are being considered, increases may need to be incorporated into future updates. A general allowance based upon our experience and consultation with elevator vendors is shown below for budgeting purposes, but any new information or cost estimates should be incorporated into future Reserve Study updates when known. Note if present, any service-only cabs are not expected to be a significant aesthetic priority and are not included here unless otherwise noted.

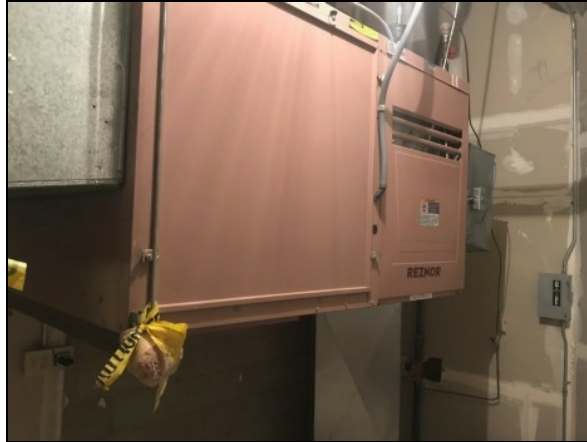
Comp #: 2523 AHU Furnace - Replace

Evaluation: Reznor model HXE250-6-SMVJ serial #EARK66KIN59926MV4. Minimal or no subjective/aesthetic value for this component. Useful life is based primarily on normal expectations for service/performance life in this location. Unless otherwise noted, remaining useful life expectancy is based primarily on original installation or last replacement/purchase date, our experience with similar systems/components, and assuming normal amount of usage and good preventive maintenance. We recommend that routine repairs and maintenance such as filter replacements, system flushing, etc. be budgeted as an Operating expense. Useful life can often be extended with proactive service and maintenance. Unless otherwise noted, funding for system with same size/capacity as the current system. For split systems, we recommend budgeting to replace the entire system (condensing unit and air handler) together in order to obtain better unit pricing and ensure maximum efficiency, refrigerant compatibility, etc. If additional costs are expected during replacement, such as for system reconfiguration or expansion, ductwork repairs, electrical work, etc. costs should be re-evaluated and adjusted as needed during future Reserve Study updates.

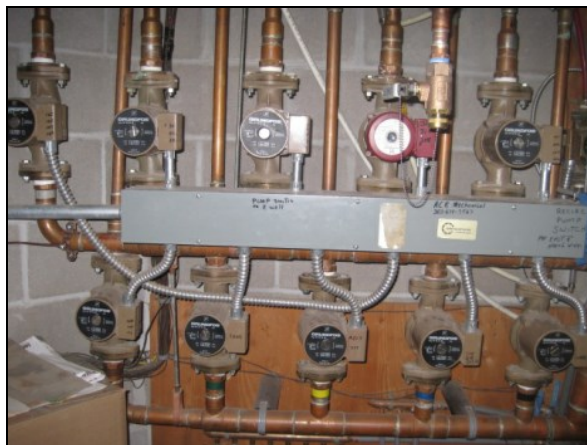
Comp #: 2533 Pumps/Valves - Repair/Replace - 33%

Evaluation: Includes (5) large Grundfos, (24) small Grundfos pumps. Expect eventual need for tear down and rebuild (more cost-effective than buying new units) at roughly the interval below. Treat smaller repair / replacement below the reserve funding threshold (< 1% of the annual operating expenses, excluding reserves) as general maintenance item(s) within operating budget.

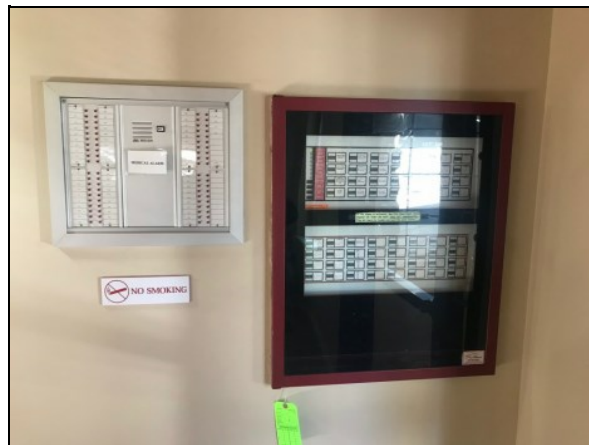
Comp #: 2553 Fire Control Panel - Update/Replace

Evaluation: Panel is a Fire-Lite model. Our inspection is for planning and budgeting purposes only fire alarm equipment is assumed to have been designed and installed properly and is assumed to comply with all relevant building codes. Regular testing and inspections should be conducted as an Operating expense. In many cases, manufacturers discontinue support of equipment after a certain number of years, which may limit availability of replacement parts as the system ages. Cost estimates assume that existing wiring can be re-used and that only panel and devices will be replaced. If wiring requires replacement, estimates should be increased accordingly, but in our experience wiring should have an indefinite useful life. Cost estimates are based on quantity and type of existing equipment, not including any expansion or upgrades, which may be required. We recommend reviewing system components with fire alarm vendor on a regular basis. If expansion of system is found to be required, the Reserve Study should be updated and any additional costs should be factored accordingly.

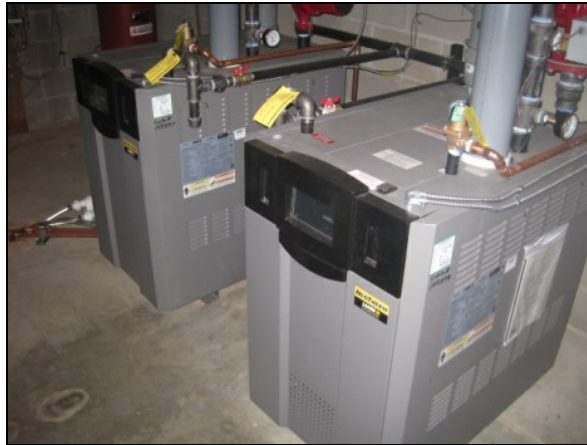
Comp #: 2561 Boilers - Replace - Heating

History: Replaced in 2017
